Manhole Inspection Summary

Manhole # S43G2_005MH

Insp Date: **11/20/08 2:59 PM**

Location Address: **West Bay Ave.**

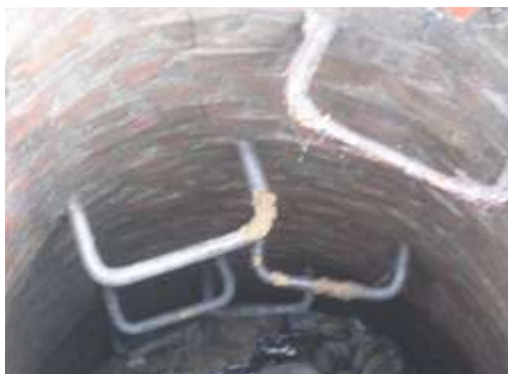
Steps

Count: **6** Missing: **0** ☒ **Corroded**

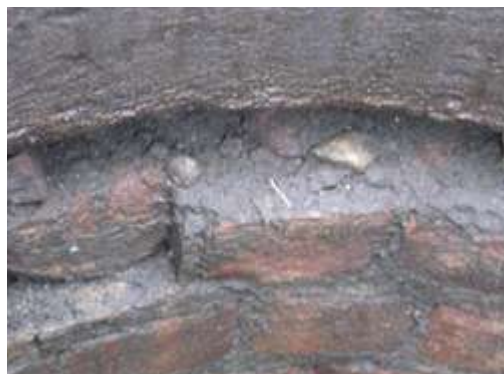
Defect 1

Condition: ☐ Sound ☐ Cracked ☐ Root Intrusion ☐ Loose Brick ☒ **Deteriorated**

Infiltration: ☐ None ☒ **Joint** ☒ **Cracks** ☐ Mortar ☐ Roots ☐ Wall

Frame-Chimney joint

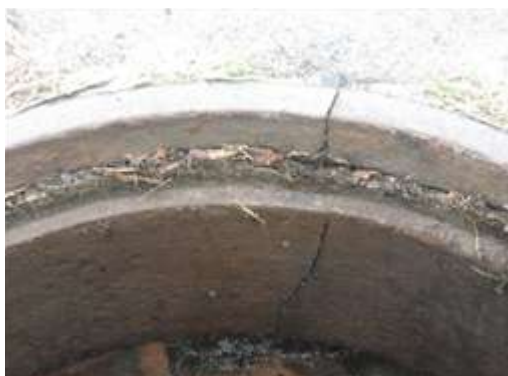
Defect 2

Condition: ☐ Sound ☒ **Cracked** ☐ Leaks

Cracked Frame

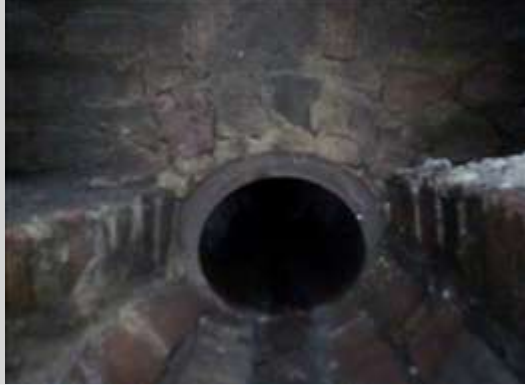
12 O'Clock Outflow

8 in. Circular Gravity Sewer
Pipe Out @ 12 O'Clock

Pipe Height: **8.4** (in.) Rod and Bar (Angled)
Pipe Material: **Clay** ☐ Pipe Lined
Invert Depth: **11.50** (ft.) Flow Characteristics: **Fast**
Deposits: ☒ None ☐ Mud ☐ Sludge ☐ Debris ☐ Grease
Silt Depth: (in.) Deposits Extent:
Infiltration: **None** Pipe Seal Cond: **Sound**

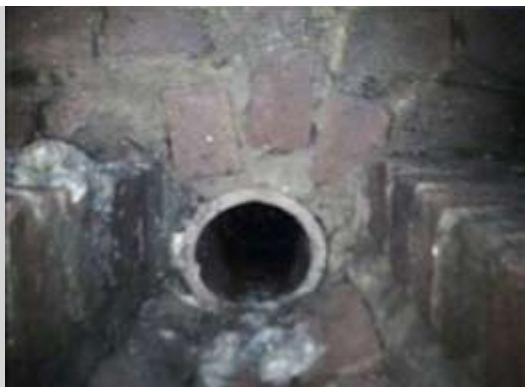
6 O'Clock Inflow

Influent pipe @ 6 O'clock too small to measure

4 in. Circular Gravity Sewer
Pipe In @ 6 O'Clock

Pipe Height: **3.6** (in.) Rod and Bar (Angled)
Pipe Material: **Clay** ☐ Pipe Lined
Invert Depth: (ft.) Flow Characteristics: **None**
Deposits: ☒ None ☐ Mud ☐ Sludge ☐ Debris ☐ Grease
Silt Depth: (in.) Deposits Extent:
Infiltration: **None** Pipe Seal Cond: **Cracked**

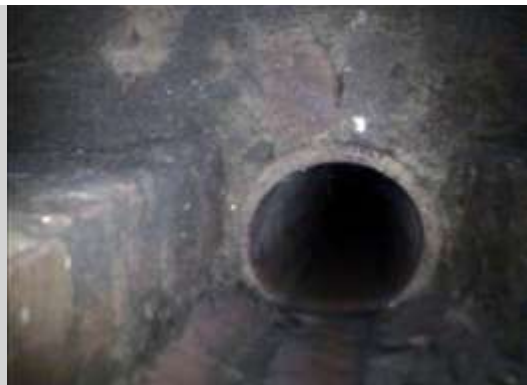
9 O'Clock Inflow

8 in. Circular Gravity Sewer

Pipe In @ 9 O'Clock

Infiltration: **None** Pipe Seal Cond: **Sound**
